BUILDING-STRUCTURE INVENTORY FORM

DIVISION FOR HISTORIC PRESERVATION NEW YORK STATE PARKS AND RECREATION ALBANY, NEW YORK (518) 474-0479

* * * * * * * * * * * * * * * * * * * *	* * * * * * * * * * * * * *	
IDENTIFICATION 1. BUILDING NAME (S):		
2. COUNTY: <u>Frie</u> TOWN/CITY: Bu	iffalo VILLAGE:	
3 STREET LOCATION: 71 Jewett Pww

American Four Square

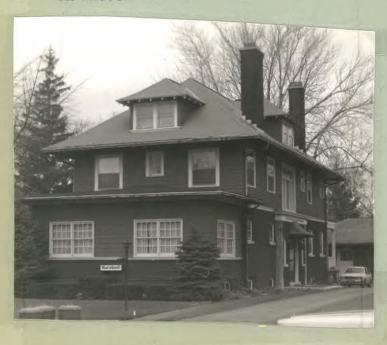
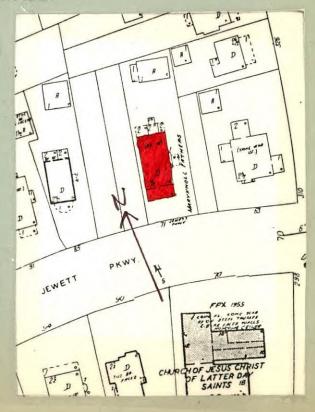
12. РНОТО: 18-21а

Two story American Four Square. Hipped roof with flared eaves. Dormers on front and east facade have hipped roofs with flared eaves and exposed rafters in eaves. Two six light over six light windows in dormers. Two interior chimneys on east side of roof. Second floor is shingled. First floor is brick. Multi-paned windows through the state of port across front of house has a slightly hipped roof. P. DATE OF INITIAL CONSTRUCTION: _c. 1920	Olmsted's Pa east of Dela and is list	arkside subdivision. aware Park which was ed on the National Re	House is four bodiesigned by Fredericker.	locks to the erick Law Olmsted
Typical example of the American Four Square that was built in the Parkside neighborhood. Jewett Parkway was originally opened in 1875 by Elam R. Jewett whose estate was at the southwest corner of Main Street and Jewett Parkway. The street followed Olmsted's plan for the Parkside neighborhood and can be seen on his 1884 map of the City of Buffalo. In 1884 Elam Jewett deeded the street to the City of Buffalo "on condition that it shall be placed in charge of the Park Commissioners, and be by them maintained as a Park approach, in the same manner as the other Park approaches now are or hereafter may be maintained." 21. SOURCES: Buffalo City Atlas 1915 Sanborn Map 1925 City of Buffalo - Park Reports 1884 "Olmsted's Sketch Map of Buffalo Showing the Relation	Two story And Dormers on and exposed in dormers. floor is shown in the state of the	merican Four Square. front and east facade rafters in eaves. The square of the square	Hipped roof with have have hipped room with the have hipped room with the have hipped room with the have have hipped room with the house hipped room with the h	h flared eaves. fs with flared eaves r six light windows of roof. Second -paned windows through nt of house has a ghtly hipped roof. rance on west side of se has metal overdoor ge four part window
