BUILDING-STRUCTURE INVENTORY FORM

DIVISION FOR HISTORIC PRESERVATION
NEW YORK STATE PARKS AND RECREATION
ALBANY, NEW YORK (518) 474-0479

- BUILDING NAME(S): _____
- COUNTY: Erie TOWN/CITY: Buffalo VILLAGE: _____
- STREET LOCATION: 82 Oakwood Pl.
- OWNERSHIP: a. public b. private
- PRESENT OWNER: Oliver Champion ADDRESS: 82 West Oakwood
- USE: Original: Residential Present: Residential
- ACCESSIBILITY TO PUBLIC: Exterior visible from public road: Yes No
Interior accessible: Explain by permission

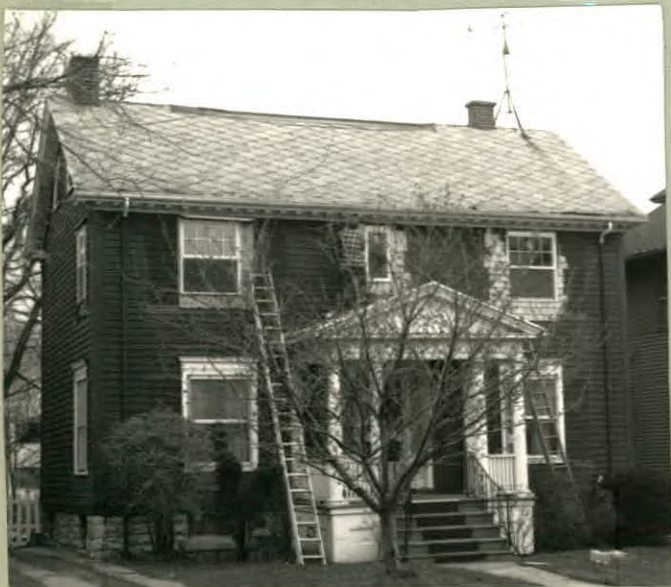
12. PHOTO: 37-7a

Two story Colonial Revival style. Side gable roof with modillions under roof eave. Cornice end returns. Symmetrical facade. Pedimented gable entrance porch, enclosed. End Doric fluted engaged columns. 4-light wood paneled door. Single-light rectangular casement windows. Frieze decorated with bull's eye motif. Dentils under cornice. First floor end bays have double-hung 1/1 windows. Entablature

BUILDER: End bays have 8/1 double-hung windows. End Doric pilaster strips.

window surround. Second floor center bay has rectangular casement window, single light.
