BUILDING-STRUCTURE INVENTORY FORM

1. BUILDING NAME(S): _____
2. COUNTY: Erie TOWN/CITY: Buffalo VILLAGE: _____
3. STREET LOCATION: 2228 Main St
4. OWNERSHIP: a. public b. private
5. PRESENT OWNER: Rhoda Surma ADDRESS: Box 67, Lake View, NY 14085
6. USE: Original: Residential Present: Residential
7. ACCESSIBILITY TO PUBLIC: Exterior visible from public road: Yes No
 Interior accessible: Explain by permission

19. DATE OF INITIAL CONSTRUCTION: 1914

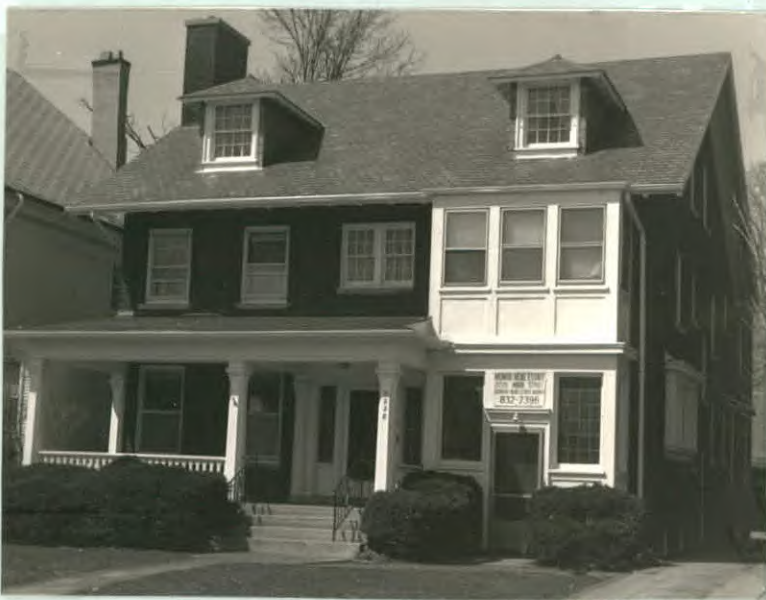
12. PHOTO: 29-2a

Two and a half story with side gable roof. Exposed rafter tails under projecting eaves. Partial-width shed roof porch. Polygonal tapered columns and cut-out patterned rail. Wood paneled door with 15 light sidelights. Pilaster strips flank entrance. Double-hung 1/1 first floor windows. Second floor center bay has pair small double-hung windows, 6/6 lights. End bay has two 1/1 light windows. Two

ARCHITECT: paneled door at ground level. Entablature window head. Large rectangular windows, 24 light opaque colored glass, flank entrance. Entablature with capping cornice spans first floor level. Second floor

has three double hung 1/1 windows, paneled apron and capping cornice. Hip roof dormers. Exposed rafter tails under projecting eaves. 8/8 light windows. A brick residence with symmetrical facade, window and door treatment reflecting Colonial Revival style influence. Originally the Buffalo and Williamsville Macadam Road, Main Street was a pre-existing street at the time Olmsted designated it as the eastern border for "The Parkside." While the streets within the subdivision were designed specifically to avoid commercial development, this portion of Main Street became a combination of commercial and residential structures. It was also a major thoroughfare into the city, allowing easy access
