BUILDING-STRUCTURE INVENTORY FORM

DIVISION FOR HISTORIC PRESERVATION  
NEW YORK STATE PARKS AND RECREATION  
ALBANY, NEW YORK (518) 474-0479

- 1. BUILDING NAME(S): \_\_\_\_\_
- 2. COUNTY: Erie TOWN/CITY: Buffalo VILLAGE: \_\_\_\_\_
- 3. STREET LOCATION: 137 Parkside Ave
- 4. OWNERSHIP: a. public  b. private
- 5. PRESENT OWNER: Elizabeth Fornes ADDRESS: 137 Parkside Avenue
- 6. USE: Original: Residential Present: Residential
- 7. ACCESSIBILITY TO PUBLIC: Exterior visible from public road: Yes  No   
Interior accessible: Explain by permission

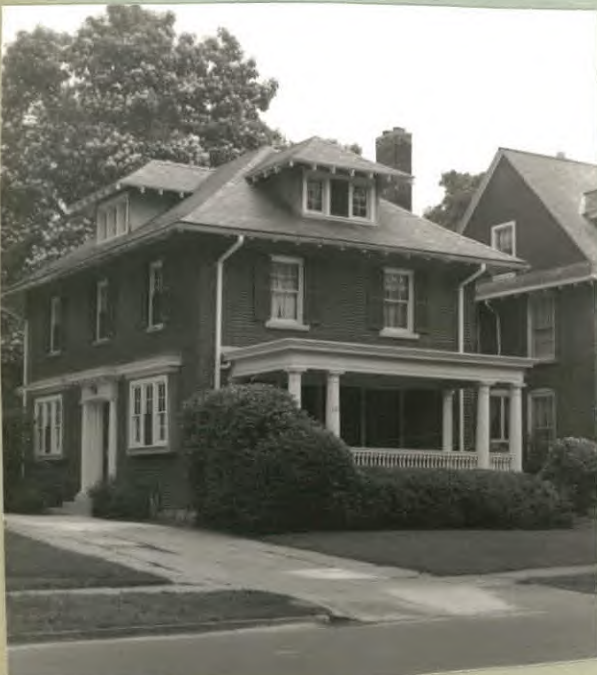
12. PHOTO: 13 - 5

18. OTHER NOTABLE FEATURES OF BUILDING AND SITE (including interior features if known):  
 Two story American Four Square with Colonial Revival styling. Hipped roof with hipped dormers. Six light over single pane windows on the second floor. Side entranceway is flanked by doric pilasters. Open porch on street facade with doric columns. House has a brick veneer.
