BUILDING-STRUCTURE INVENTORY FORM DIVISION FOR HISTORIC PRESERVATION NEW YORK STATE PARKS AND RECREATION ALBANY, NEW YORK (518) 474-0479 FOR OFFICE USE ONLY 029-40 5293 UNIQUE SITE NO. 9 1000000000000000000000000000000000000
YOUR NAME: POLEON SED PARKS DATE: JAN 1 0 1983

2. COUNTY: Erie TOWN/CITY: Buffalo VILLAGE:
3. STREET LOCATION: 149 Parkside Ave
4. OWNERSHIP: a. public b. private A
5. PRESENT OWNER: Dorothy A. Boyd ADDRESS: 149 Parkside Avenue

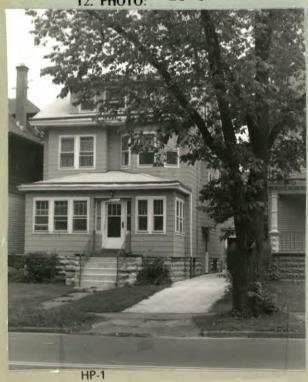
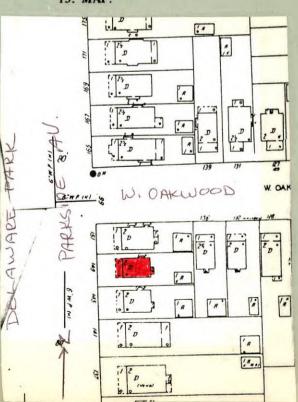
12. РНОТО: 13-8

e. other
10. CONDITION: a. excellent D b. good X c. fair d. deteriorated D
11. INTEGRITY: a. original site 🖾 b. moved 🗆 if so, when?
c. list major alterations and dates (if known): new siding

Two story American Four Square. Gable roof with returns. Shed dormer with three light over single pane windows on front facade. Projecting bay in center of south facade over doorway. Three sided projecting bay on first floor, and a two sided bay on the second floor of the north facade. Second floor front facade has a four sided bay to the north and a three sided bay to the south, both have single pane double-hung SIGNIFICANCE

windows. Enclosed porch across front of house has a hip roof and three light over single pane windows. Stone foundation.
 Typical example of the American Four Square style that was built
