BUILDING-STRUCTURE INVENTORY FORM

- 1. BUILDING NAME(S): _____
- 2. COUNTY: Erie TOWN/CITY: Buffalo VILLAGE: _____
- 3. STREET LOCATION: 247 Parkside Ave
- 4. OWNERSHIP: a. public b. private
- 5. PRESENT OWNER: Benjamin Guttuso ADDRESS: 247 Parkside Avenue
- 6. USE: Original: Residential Present: Residential
- 7. ACCESSIBILITY TO PUBLIC: Exterior visible from public road: Yes No
Interior accessible: Explain by permission

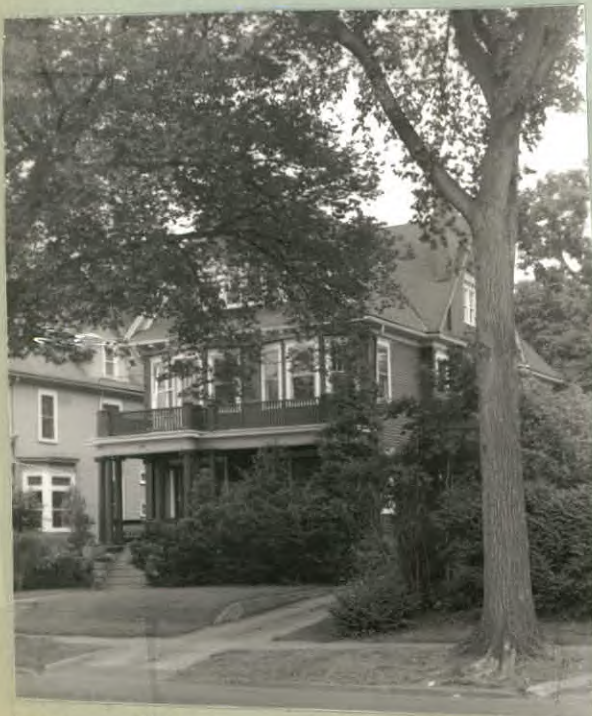
12. PHOTO: 13-23

Two story Colonial Revival style. Cross gable roof. Four nine light over single pane windows in shingled gable. Modillion like brackets under eaves of front facade. Exterior brick chimney on south side of house. Entranceway on south side of house. Two bays on second story front facade have three four light over single pane windows. Open porch across front of house has Ionic columns, dentils in cornice and a stick

18. balustrade on both first and second story. Front entranceway has leaded glass sidelights.
