BUILDING-STRUCTURE INVENTORY FORM

DIVISION FOR HISTORIC PRESERVATION
 NEW YORK STATE PARKS AND RECREATION
 ALBANY, NEW YORK (518) 474-0479

1. BUILDING NAME(S): _____
2. COUNTY: Erie TOWN/CITY: Buffalo VILLAGE: _____
3. STREET LOCATION: 2384 Main St
4. OWNERSHIP: a. public b. private 2 Willow Lawn
5. PRESENT OWNER: Vincent Krug ADDRESS: Buffalo, NY 14214
6. USE: Original: Residential Present: Residential
7. ACCESSIBILITY TO PUBLIC: Exterior visible from public road: Yes No
 Interior accessible: Explain by permission

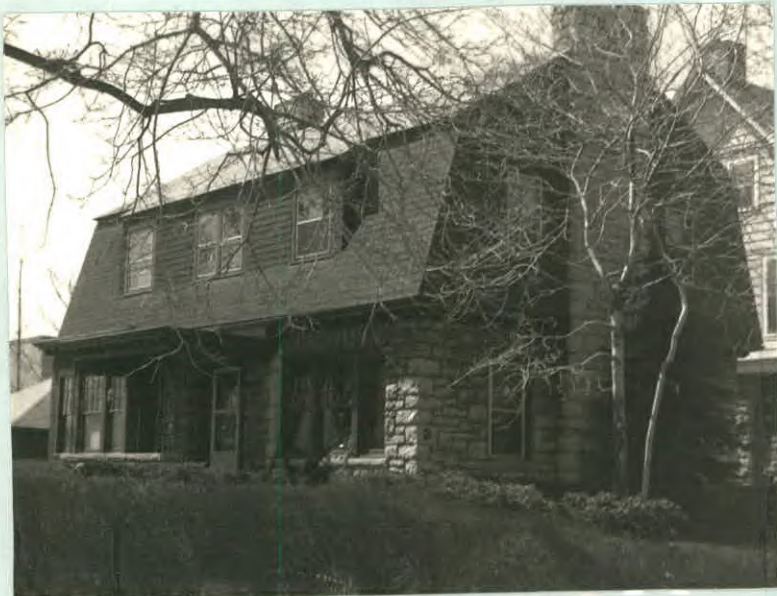
12. PHOTO: 29-25a & 34-33a

Two story Dutch Colonial Revival style. Gambrel roof. Rough cut, irregular course stone first floor. Flat-roof entrance porch with rounded end brackets under cornice. Opaque glass paneled door with leaded sidelights. Relieving arch. End bays first floor have tri-part windows; 12/1 center with 9/1 sides.

- SIGNIFICANCE Relieving arch. Round end brackets under roof eave.
19. DATE OF INITIAL CONSTRUCTION: c. 1910 Shed roof dormer has center
paired double-hung 1/1
ARCHITECT: _____ windows with flanking
double-hung 1/1 windows.
BUILDER: _____
