BUILDING-STRUCTURE INVENTORY FORM

1. BUILDING NAME(S): _____
2. COUNTY: Erie TOWN/CITY: Buffalo VILLAGE: _____
3. STREET LOCATION: 162 Summit Ave
4. OWNERSHIP: a. public b. private
5. PRESENT OWNER: John Donovan ADDRESS: 162 Summit
6. USE: Original: Residential Present: Residential
7. ACCESSIBILITY TO PUBLIC: Exterior visible from public road: Yes No
 Interior accessible: Explain by permission

American Four Square/ Craftsman Styling

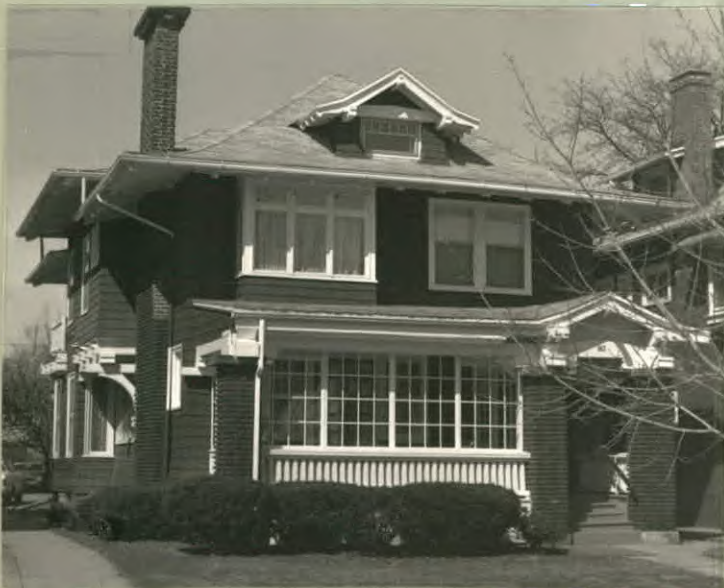
12. PHOTO: 27-25a

Two and a half story with Craftsman styling. Hip roof with flared projecting eaves. Exposed rafter tails. Full-width shed roof porch, partially enclosed. Gable end projection has brick pier supports. Trellis-style brackets support pediment-shaped panel and gable with bargeboard. Recessed entrance has lighted wood panel door with transom. Four 16-light porch windows, stick balustrade. Second

19. DATE OF INITIAL CONSTRUCTION: 1909
 ARCHITECT: single light windows with transom. Paired 6/1 light second floor windows. Gabled dormer with flared eaves and curved exposed rafter tails. Brackets support bargeboard. 6/1 window with pediment-shaped panel above.
 BUILDER: _____
