**BUILDING-STRUCTURE INVENTORY FORM**

1. BUILDING NAME(S): \_\_\_\_\_
2. COUNTY: Erie TOWN/CITY: Buffalo VILLAGE: \_\_\_\_\_
3. STREET LOCATION: 269 Parkside Ave
4. OWNERSHIP: a. public  b. private
5. PRESENT OWNER: Robert Olesko ADDRESS: 269 Parkside Avenue
6. USE: Original: Residential Present: Residential
7. ACCESSIBILITY TO PUBLIC: Exterior visible from public road: Yes  No   
 Interior accessible: Explain by permission

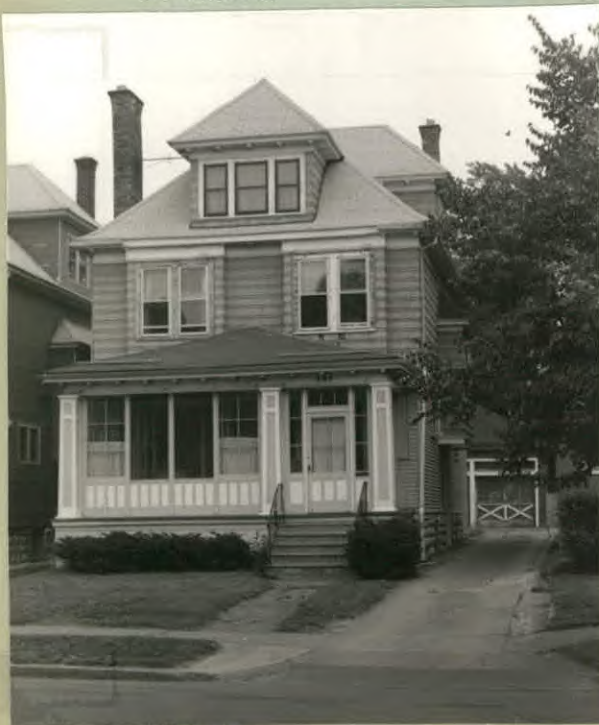
12. PHOTO: 13-29

Two story American Four Square. Hip roof with flared eaves and modillion like brackets in cornice. Hipped dormers on west and south sides of house have three double-hung windows and modillion like brackets in cornice. Projecting bay with a hip roof in center of south side of house. Two projecting bays with a pair of double hung windows in each on the second story front facade. Enclosed porch across front of house

18. has a hip roof and modillion like brackets in the cornice. Porch has squared tapered porch posts with recessed panels, a paneled balustrade and six light windows. Stone foundation.
