BUILDING-STRUCTURE INVENTORY FORM

3. S	STREET LOCATION: 137 Crescent AVE	
4. (OWNERSHIP: a. public b. private	
5. P	PRESENT OWNER: Doris Hickenbottom AL	DDRESS: 137 Crescent
6. L	USE: Original: Residential Pre	sent: Residential

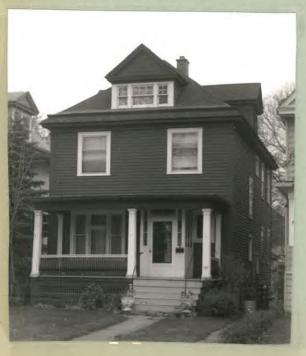
12. PHOTO: 11-21a

18. OTHER NOTABLE FEATURES OF BUILDING AND SITE (including interior features if known): Two and a half story with hip roof. Full-width flat roof porch has square doric supports and bowed baluster balustrade. Projecting entrance has 8-light door with 2-light transom and 3-light sidelights Rectangular leaded window flanks. Tri-part first floor window, center; single light with leaded transom and 1/1 sidelights. SIGNIFICANCE Second floor 6/1 windows. End doric pilaster strips. Pedimented gable dormer. Tri-part window, 6/1 center
ARCHITECT: with 4/1 sides.
BUILDER:
