**BUILDING-STRUCTURE INVENTORY FORM**

- BUILDING NAME(S): \_\_\_\_\_
- COUNTY: Erie TOWN/CITY: Buffalo VILLAGE: \_\_\_\_\_
- STREET LOCATION: 119 Greenfield St
- OWNERSHIP: a. public  b. private
- PRESENT OWNER: John Blain ADDRESS: 119 Greenfield
- USE: Original: Residential Present: Residential
- ACCESSIBILITY TO PUBLIC: Exterior visible from public road: Yes  No   
Interior accessible: Explain by permission

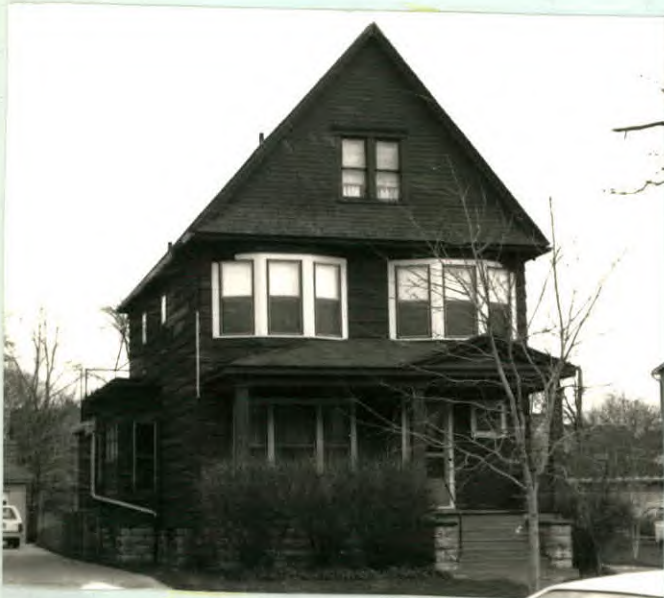
12. PHOTO: 32-32a

18. OTHER NOTABLE FEATURES OF BUILDING AND SITE (including interior features if known):  
 Two and a half story frame residence with steep pitched front facing gable roof. Full-width hip roof porch with pediment at right end. Rough cut, regular course stone base. Three square supports. Glass and wood paneled door flanked by small square leaded window. Three-part first floor window. Double hung 1/1 windows. Plain window surround. Pedimented gable, shingled, extends over

19. DATE OF INITIAL CONSTRUCTION: 1908  
 ARCHITECT: brackets. Paired double hung 1/1 windows. Entablature window head.  
 BUILDER: \_\_\_\_\_
