BUILDING-STRUCTURE INVENTORY FORM

1. BUILDING NAME(S): _____
2. COUNTY: Erie TOWN/CITY: Buffalo VILLAGE: _____
3. STREET LOCATION: 212 Summit Ave
4. OWNERSHIP: a. public b. private
5. PRESENT OWNER: Joseph O'Grady ADDRESS: 212 Summit
6. USE: Original: Residential Present: Residential
7. ACCESSIBILITY TO PUBLIC: Exterior visible from public road: Yes No
 Interior accessible: Explain by permission

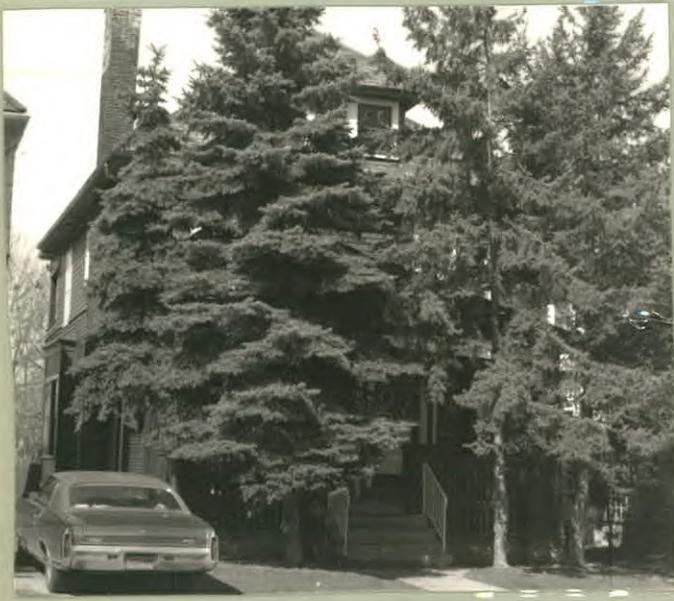
12. PHOTO: 27-34a

18. OTHER NOTABLE FEATURES OF BUILDING AND SITE (including interior features if known):
Two and a half story American Four Square with Craftsman styling. Hip roof. Full-width gabled porch. Tapered paneled square supports. Stick rail. Projecting entrance with diamond light wood paneled door. First floor tri-part window, single lights with diamond-shaped tracery in transoms. Clapboard first floor. End bays second floor have paired double hung windows.

- SIGNIFICANCE
19. DATE OF INITIAL CONSTRUCTION: 1914 Diamond-shaped tracery in top light. Lighted transoms. Shingle second floor. Hip roof dormer has two double hung windows with diamond tracery in top light.
ARCHITECT: _____
BUILDER: _____
