BUILDING-STRUCTURE INVENTORY FORM

* * * * * * * * * * * * * * * * * * * *
DENTIFICATION
I. BUILDING NAME(S):
2. COUNTY: Erie TOWN/CITY: Buffalo VILLAGE:
2. COUNTY: Erie TOWN/CITY: Buffalo VILLAGE: 3. STREET LOCATION: 217 Summit Ave

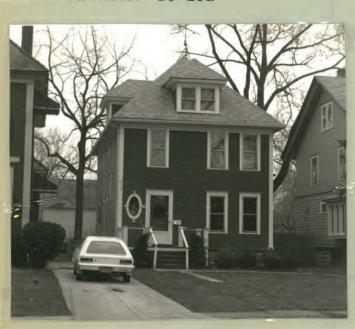
12. PHOTO: 26-16a

d. metal (explain)
e. other
). CONDITION: a. excellent □ b. good ☑ c. fair □ d. deteriorated □
1. INTEGRITY: a. original site 🖾 b. moved 🗆 if so, when?
c. list major alterations and dates (if known):
Porch removed

18. OTHER NOTABLE FEATURES OF BUILDING AND SITE (including interior features if known): Two and a half story Colonial Revival style. Hip roof. Wood paneled door with circular glass panel flanked on one side by elliptical leaded window with surround and keystones. First floor 1/1 windows with entablature window surround. Second floor windows placed under roof eave. 1/1 lights. End pilaster SIGNIFICANCE strips. Hip roof dormer has pair 1/1 windows. 19. DATE OF INITIAL CONSTRUCTION: c. 1908	
ARCHITECT:	
BUILDER:
