**BUILDING-STRUCTURE INVENTORY FORM**

1. BUILDING NAME(S): \_\_\_\_\_
2. COUNTY: Erie TOWN/CITY: Buffalo VILLAGE: \_\_\_\_\_
3. STREET LOCATION: 351 Parkside Ave
4. OWNERSHIP: a. public  b. private
5. PRESENT OWNER: Rita M. Blankenberg ADDRESS: 351 Parkside Avenue
6. USE: Original: Residential Present: Residential
7. ACCESSIBILITY TO PUBLIC: Exterior visible from public road: Yes  No   
 Interior accessible: Explain by permission

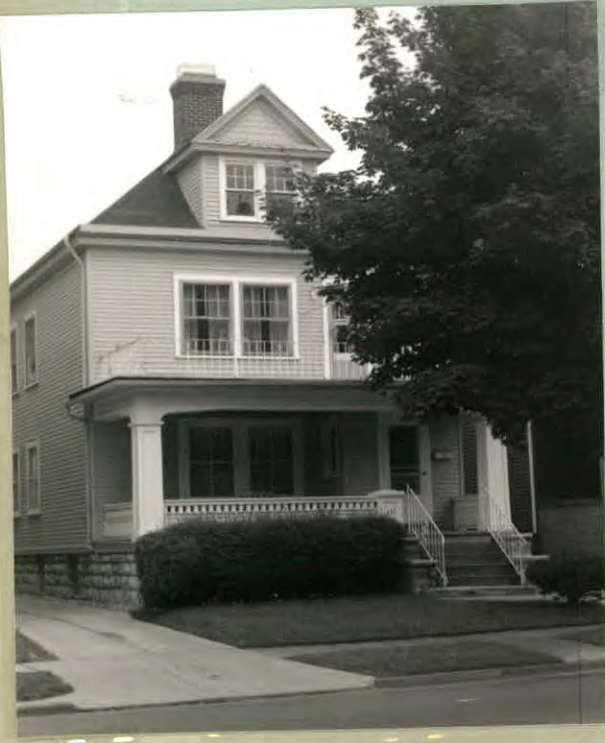
12. PHOTO: 14-6a

Two story frame house. Hip roof. Gabled dormer with two six over single pane windows. Two eight over single pane windows and doorway that leads out to the second floor open porch on second floor front facade. Open porch across front of house has tapered squared posts with recessed panels. Stone foundation.
