BUILDING-STRUCTURE INVENTORY FORM

- 1. BUILDING NAME(S): \_\_\_\_\_
- 2. COUNTY: Erie TOWN/CITY: Buffalo VILLAGE: \_\_\_\_\_
- 3. STREET LOCATION: 401 Parkside Ave
- 4. OWNERSHIP: a. public  b. private
- 5. PRESENT OWNER: Ronald F. Mandell ADDRESS: 401 Parkside Avenue
- 6. USE: Original: Residential Present: Residential
- 7. ACCESSIBILITY TO PUBLIC: Exterior visible from public road: Yes  No   
Interior accessible: Explain by permission

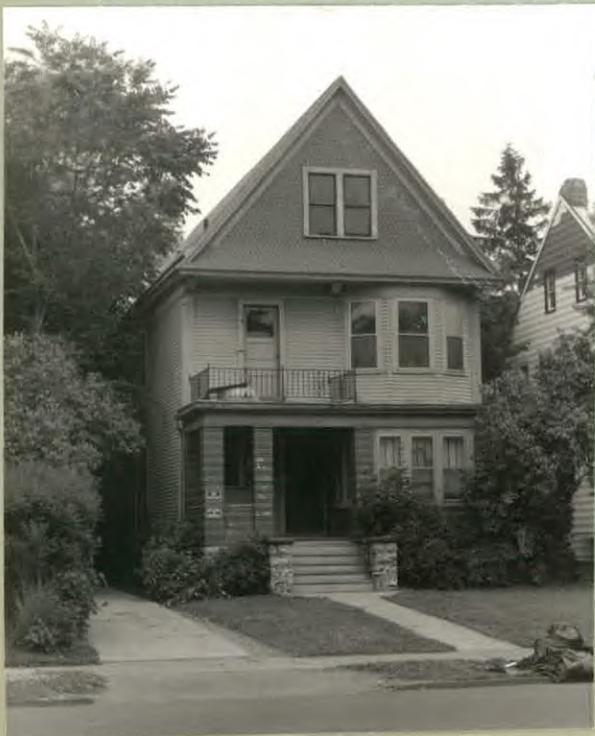
12. PHOTO: 14-13a

18. OTHER NOTABLE FEATURES OF BUILDING AND SITE (including interior features if known):  
 Two story frame house. Shingled gable with two double hung windows. Bay window and doorway on second floor front facade. Pilaster corner boards. Three large modillion-like brackets in the eaves of the front gable. Porch across front of house with shingled squared posts.
