BUILDING-STRUCTURE INVENTORY FORM DIVISION FOR HISTORIC PRESERVATION NEW YORK STATE PARKS AND RECREATION ALBANY, NEW YORK (518) 474-0479 FOR OFFICE USE ONLY 025-40 5655 D 040 SERIES NEG. NO.
YOUR NAME: BUFFALO FRIENDS OF OLMSTED PARKS DATE: April 23, 1984

2. COUNTY: TOWN/CITY: Buffalo VILLAGE:
3. STREET LOCATION: 239 Summit AVE
4. OWNERSHIP: a. public D b. private 🖾
5. PRESENT OWNER: Lula Bihl ADDRESS: 239 Summit

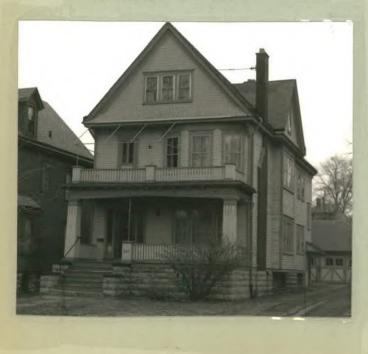
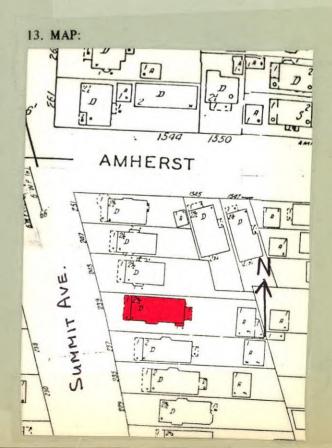
12. PHOTO: 26-22a

18. OTHER NOTABLE FEATURES OF BUILDING AND SITE (including interior features if known): Two and a half story frame residence with front facing gable roof. Full-width flat roof porch has tapered square supports with column elaboration. Stick balustrade. Arched span between supports. Brackets under roof eave. Glass paneled door with leaded sidelights. First floor three-part window, single lights with leaded transom. Upper floor stick balustrade. Semi-hexagonal second

SIGNIFICANCE 19. DATE OF INITIAL CONSTRUCTION: 1913 floor bay, 1/1 windows

with entablature window ARCHITECT: surround. Rectangular glass paneled and wood paneled porch door. Shingled pedimented gable BUILDER: with curved end brackets under projection. Three

part window with prism-shaped tracery in top light. 20. HISTORICAL AND ARCHITECTURAL IMPORTANCE: Entablature window surround.

A typical frame gable residence that makes use of Craftsman styling in porch. Summit Avenue is a truncated north-south street, located between Woodward and Crescent Avenues and extending from West Oakwood Place to the northern section of Crescent Avenue. A similar street, ending south of Jewett Avenue, appears in Olmsted's early 1870's maps of "The Parkside." Summit Avenue was deeded to the city in 1889, except for the small section between Amherst and Crescent which was deeded in 1892. This street follows Olmsted's rule that it "not lead with special directness toward the town."
