BUILDING-STRUCTURE INVENTORY FORM

- 1. BUILDING NAME(S): _____
- 2. COUNTY: Erie TOWN/CITY: Buffalo VILLAGE: _____
- 3. STREET LOCATION: 434 Parkside Ave
- 4. OWNERSHIP: a. public b. private
- 5. PRESENT OWNER: Marie O'Connor ADDRESS: 434 Parkside Avenue
- 6. USE: Original: Residential Present: Residential
- 7. ACCESSIBILITY TO PUBLIC: Exterior visible from public road: Yes No
Interior accessible: Explain by permission

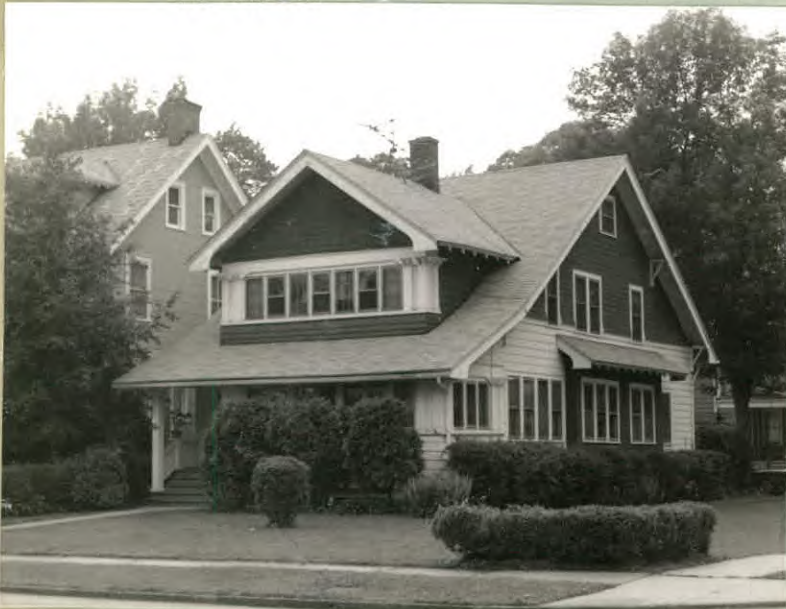
12. PHOTO: 14-34a

One an half story Bungalow style. Gable roof with flared eaves over front enclosed porch. Purlins in gables. Large gabled dormer with a plain vergeboard and exposed rafters. Seven nine light windows in dormer flanked by three pilasters with extended brackets as capitals. One story bay on north side of house has six windows and a shed roof. Side entranceways on south side of house. Enclosed porch across front

18. of house has nine light windows and pilasters similar to those in the dormer. Recessed entranceway to the south of the enclosed porch has a squared column and stick railing.
