BUILDING-STRUCTURE INVENTORY FORM

1. BUILDING NAME(S): _____
2. COUNTY: Erle TOWN/CITY: Buffalo VILLAGE: _____
3. STREET LOCATION: 458 Parkside Ave
4. OWNERSHIP: a. public b. private
5. PRESENT OWNER: Joseph Marciano ADDRESS: 458 Parkside Avenue
6. USE: Original: Residential Present: Residential
7. ACCESSIBILITY TO PUBLIC: Exterior visible from public road: Yes No
 Interior accessible: Explain by permission

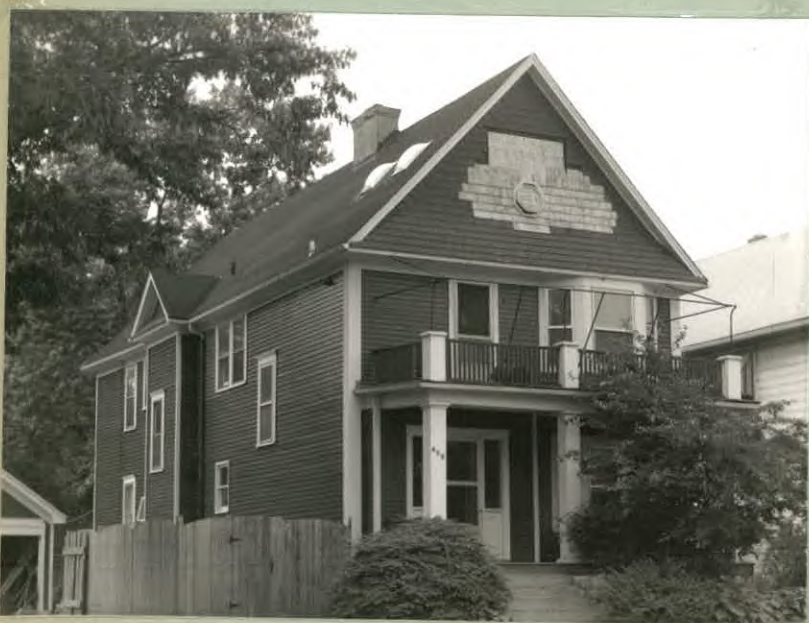
12. PHOTO: 14-30a

Two story frame house. Gable roof. Shingled gable. Narrow gabled projecting pavillion on south side of house. Open porch across front of house has squared posts. Bay window and door leading out to the second floor porch on second floor front facade. Entranceway has leaded glass sidelights
