BUILDING-STRUCTURE INVENTORY FORM

DIVISION FOR HISTORIC PRESERVATION
 NEW YORK STATE PARKS AND RECREATION
 ALBANY, NEW YORK (518) 474-0479

1. BUILDING NAME(S): _____
2. COUNTY: Erie TOWN/CITY: Buffalo VILLAGE: _____
3. STREET LOCATION: 461-63 Parkside Ave
4. OWNERSHIP: a. public b. private
5. PRESENT OWNER: Mark J. Mahoney ADDRESS: 461-63 Parkside
6. USE: Original: Residential Present: Residential
7. ACCESSIBILITY TO PUBLIC: Exterior visible from public road: Yes No
 Interior accessible: Explain by permission

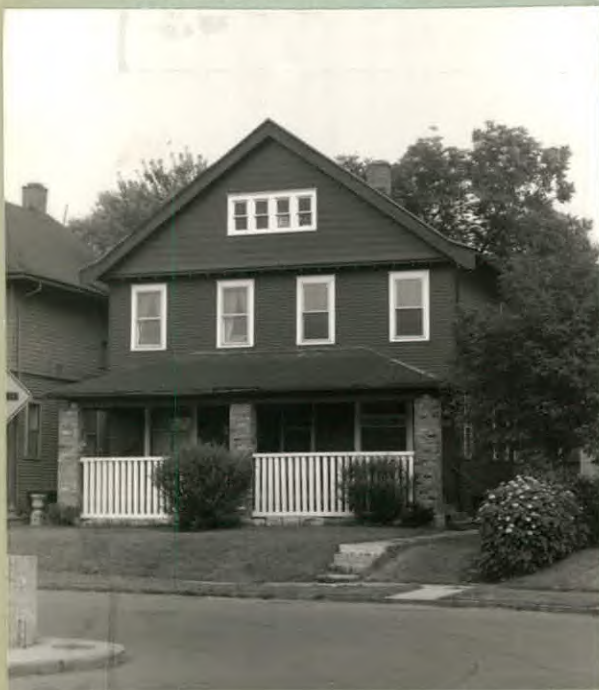
12. PHOTO: 14-27a

8. BUILDING MATERIAL: a. clapboard b. stone c. brick d. board and batten
 e. cobblestone f. shingles g. stucco other: _____
9. STRUCTURAL SYSTEM: a. wood frame with interlocking joints
 (if known) b. wood frame with light members
 c. masonry load bearing walls
 d. metal (explain) _____
 e. other _____
10. CONDITION: a. excellent b. good c. fair d. deteriorated
11. INTEGRITY: a. original site b. moved if so, when? _____
 c. list major alterations and dates (if known): Porch piers have been rebuilt.

Two story American Four Square. Gable roof. Gable is shingled with four double-hung windows, a plain vergeboard and modillion-like brackets in the cornice. Four double-hung windows on second floor front facade. Open porch across front of house has a hipped roof and brick piers.
