BUILDING-STRUCTURE INVENTORY FORM

YOUR NAME: BUFFALO FRIENDS OF OLMSTED PARKS DATE: March 30, 1984

1. BUILDING NAME(S): _____
2. COUNTY: Erie TOWN/CITY: Buffalo VILLAGE: _____
3. STREET LOCATION: 299 Woodward Ave
4. OWNERSHIP: a. public b. private
5. PRESENT OWNER: Frank Vasi ADDRESS: 299 Woodward
6. USE: Original: Residential Present: Residential
7. ACCESSIBILITY TO PUBLIC: Exterior visible from public road: Yes No
 Interior accessible: Explain by permission

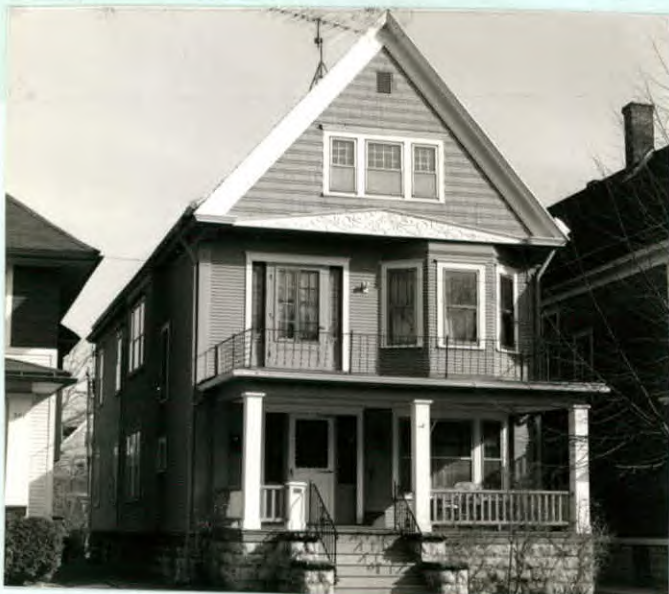
12. PHOTO: 24-23a

Two and a half story with Colonial Revival style details. Steep pitched front facing gable roof. Full-width porch has square Doric supports, stick balustrade, projecting cornice. Wood-paneled door flanked by leaded sidelights. Tri-part first floor window with center single light with transom and sized, single light with leaded transoms. Second floor semi-hexagonal bay window with 3

19. DATE OF INITIAL CONSTRUCTION: 1912 vertical lights over 1. Multi-light casement porch door with
 ARCHITECT: leaded sidelights. Entablature window and door surround.
 BUILDER: Second story pediment contained in gable, vine motif in relief. Pedimented gable with cornice end returns. Tri-part window, 12/1 center with 9/1 flanking windows.

20. HISTORICAL AND ARCHITECTURAL IMPORTANCE: Building end pilaster strips with ancones above.
