BUILDING-STRUCTURE INVENTORY FORM DIVISION FOR HISTORIC PRESERVATION NEW YORK STATE PARKS AND RECREATION ALBANY, NEW YORK (518) 474-0479	FOR OFFICE USE ONLY UNIQUE SITE NO. 0 5824 DO QUAD SERIES NEG. NO
YOUR NAME:BUFFALO FRIENDS OF OLMSTED PA	RKS DATE: March 30, 1984

I. BUILDING NAME (S):	
COUNTY: Erie TOWN/CITY	Buffalo VILLAGE:
2. COUNTY: Erie TOWN/CITY 3. STREET LOCATION: 351 Woodward AV	e
4. OWNERSHIP: a. public D b. private 🕱

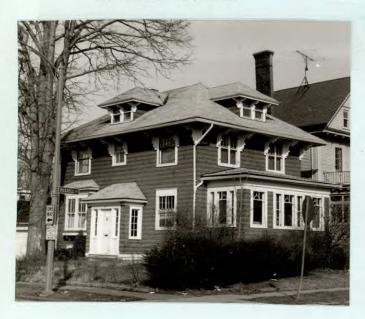
12. PHOTO: 24-34a

18. OTHER NOTABLE FEATURES OF BUILDING AND SITE (including interior features if known): Two and a half story with Craftsman styling. Hip roof with extending eaves. Paired ornately carved brackets. Hip roof entrance porch has wood paneled door with sidelights. First floor oriel with brack-t supports. Hip roof. Arched tracery in top light. Entablature window surround. First and second floor windows with arched tracery in top light. Hip 19. DATE OF INITIAL CONSTRUCTION: 1909 roof dormer with paired brackets under extending

ARCHITECT: eave. South side has hip roof wing. Single light windows with semi-circular BUILDER: tracery in top light. Center window flanked by 4 light sidelights.
