BUILDING-STRUCTURE INVENTORY FORM	FOR OFFICE USE ONLY
BUILDING-STRUCTURE INVENTORT FORM	UNIQUE SITE NO. 40 5748
DIVISION FOR HISTORIC PRESERVATION	
NEW YORK STATE PARKS AND RECREATION	QUAD
	SERIES
ALBANY, NEW YORK (518) 474-0479	NEG. NO
YOUR NAME: BUFFALO FRIENDS OF OLMSTED PAI	KS DATE: <u>March 30, 1984</u>

* * * * * * * * * * * * * * * * * * * *	* * * * * * * * * * * * * * * *
IDENTIFICATION	
1. BUILDING NAME (S):	
2 COUNTY Erie TOWN/CITY	BuffaloVILLAGE:
3. STREET LOCATION: 452 Woodward Ave	2

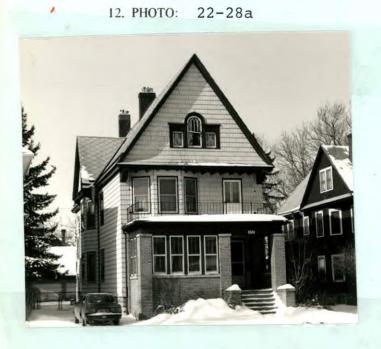
d. metal (explain)	
e. other	
0. CONDITION: a. excellent 🗌 b. good 🖾 c	
1. INTEGRITY: a. original site 🗵 b. moved 🗌	if so,when?
c. list major alterations and dates (if	known):
Porch is later addit:	Lon

18. OTHER NOTABLE FEATURES OF BUILDING AND SITE (including interior features if known): Two and a half story with Colonial Revival style details. Steep pitch front facing gable roof. Full-width porch has partial width enclosed wing. Horizontal band of 3 vertical lights over 1 windows. Brick piers. Recessed entrance. Glass paneled door. Second floor has semi-hexagonal bay. 1/1 light windows. Double sash multi-light porch doors. Pedimented gable has SIGNIFICANCE brackets and end ancones 19. DATE OF INITIAL CONSTRUCTION: 1903 under projection. Palladian style window. South side ARCHITECT: has pedimented gable and two story semi-hexagonal bay.
