BUILDING-STRUCTURE INVENTORY FORM DIVISION FOR HISTORIC PRESERVATION NEW YORK STATE PARKS AND RECREATION ALBANY, NEW YORK (518) 474-0479	FOR OFFICE USE ONLY UNIQUE STE S. 5838 QUAD
YOUR NAME:BUFFALO FRIENDS OF OLMSTED PARI P. O. BOX 590 YOUR ADDRESS:BUFFALO, NEW YORK 14205 - 0590 ORGANIZATION (if any):	TELEPHONE:

* * * * * * * * * * * * * * * * * * *	* * * * * * * * * * * * * * * * * * * *
2. COUNTY:       Erie       TOWN/CITY:       Bi         3. STREET LOCATION:       465 Woodward       A         4. OWNERSHIP:       a. public       b. private X	/e

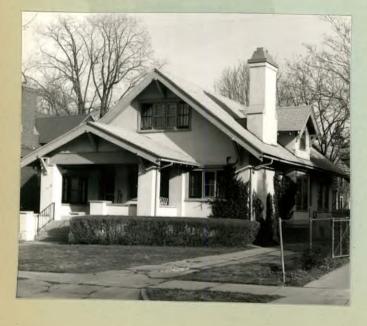
12. PHOTO: 25-16a

e. other 10. CONDITION: a. excellent □ b. good ⊠ c. 11. INTEGRITY: a. original site ⊠ b. moved □ c. list major alterations and dates (if k	fair d. deteriorated

18. OTHER NOTABLE FEATURES OF BUILDING AND SITE (including interior features if known): Two story Craftsman style. Front facing gable roof. Projecting eaves with bargeboard and triangular knee braces. Partial width porch has gable roof with bargeboard and triangular knee braces. Massive square supports, plain rail and contrasting tie beam. Recessed glass paneled door. Tri-part window on first floor and <u>4 part window</u> in gable. Three vertical lights with two square panes 19. DATE OF INITIAL CONSTRUCTION: 1912 decorate each window. North

side has boxed bay window and gabled dormer.
