BUILDING-STRUCTURE INVENTORY FORM

YOUR NAME: BUFFALO FRIENDS OF OLMSTED PARKS DATE: February 3, 1984
P. O. BOX 590

- 1. BUILDING NAME(S): _____
- 2. COUNTY: Erie TOWN/CITY: Buffalo VILLAGE: _____
- 3. STREET LOCATION: 679 Crescent Ave
- 4. OWNERSHIP: a. public b. private
- 5. PRESENT OWNER: Robert Reidpath Jr. ADDRESS: 679 Crescent
- 6. USE: Original: Residential Present: Residential
- 7. ACCESSIBILITY TO PUBLIC: Exterior visible from public road: Yes No
Interior accessible: Explain by permission

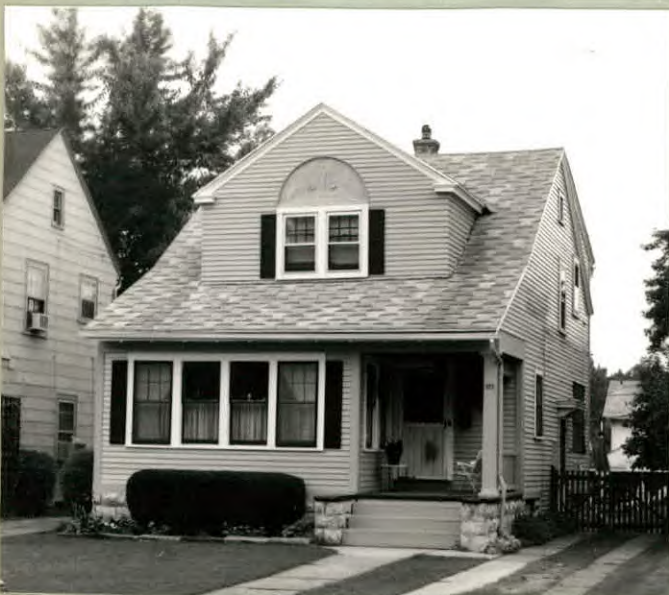
12. PHOTO: 7-9a

18. OTHER NOTABLE FEATURES OF BUILDING AND SITE (including interior features if known):
 Two story bungalow style with Colonial Revival details. Side gable roof with front extension to form first floor wing and porch roof. Wing has horizontal band of 6/1 windows. End window shutters. Recessed entrance has square doric corner support. Multi-light glass door. Over-sized gabled dormer with cornice end returns. Paired 6/1 windows. Window shutter.

20. HISTORICAL AND ARCHITECTURAL IMPORTANCE: An adaptation of the Colonial Revival style on a bungalow style residence. Similar to 723 Crescent in building plan. Crescent Avenue is the longest curvilinear street in the Parkside subdivision, stretching from Humboldt Avenue to Colvin Street. This street appears on Olmsted's early 1870's maps of "The Parkside." By the 1880's plans for Crescent Avenue had been modified by Olmsted to its current form. Portions of the street were deeded to the city by five different owners over a span of five years, beginning in 1887 near Humboldt and ending in 1892 near Colvin. Crescent Avenue begins and ends within the Parkside subdivision, following Olmsted's rule that a suburban neighborhood street "not lead with special directness toward the town."
21. SOURCES:
